FINAL REPORT *OF* A BOARD OF INVESTIGATION

*To Inquire Into*  
THE DESIGN  
AND METHODS OF CONSTRUCTION  
OF WELDED STEEL MERCHANT  
VESSELS

15 JULY 1946

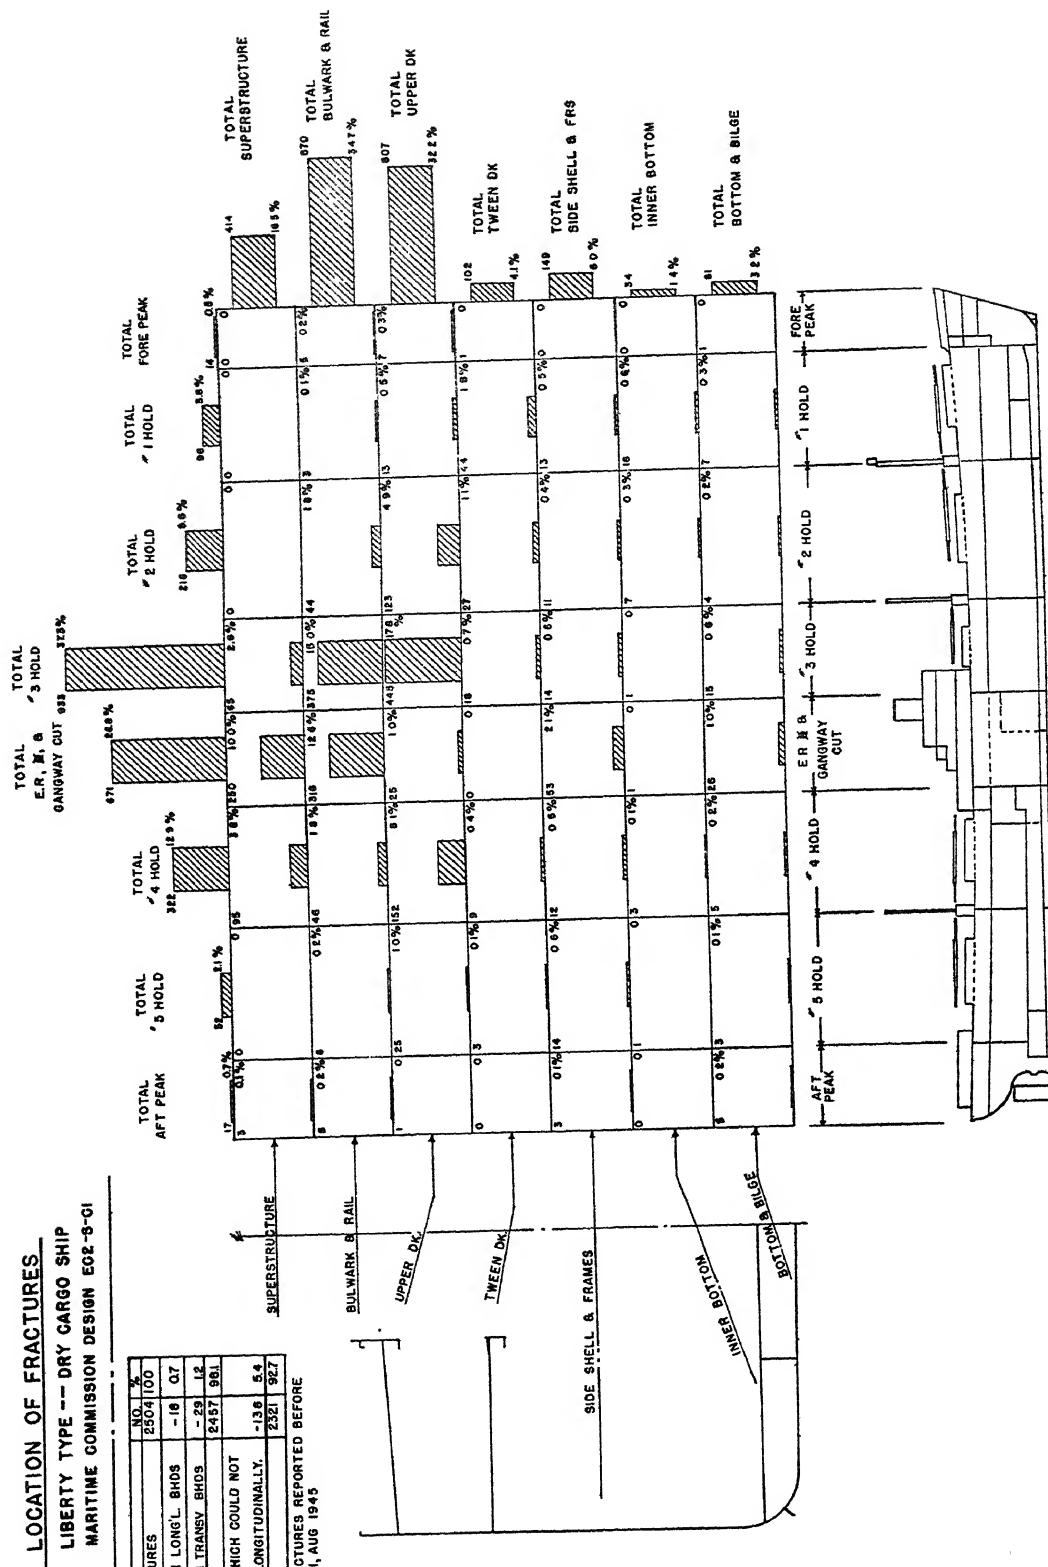
Figure 30.

A plot, figure 30, has been prepared showing the longitudinal and vertical location of all classes of fractures on the Liberty ships. This chart indicates that the fractures peak up near amidships in the upper deck and in the bottom with few fractures in the tween decks, indicating that longitudinal bending stresses play an important part in their distribution. The tabulation also shows the magnifying effect of certain design features such as the hatch corners which were responsible for 612 fractures or 24.4 percent. The sketch of the EC2-S-C1 vessel indicates the effect quite clearly, figure 31.

NOTE: NUMBER IN THE UPPER LEFT CORNER OF EACH SQUARE INDICATES THE NUMBER OF FRACTURES THAT HAVE OCCURRED IN THAT PARTICULAR SECTION OF VESSEL. THE NUMERAL IN THE UPPER RIGHT CORNER INDICATES THE PER CENT OF THE TOTAL FRACTURES OF ALL SECTIONS (2504)

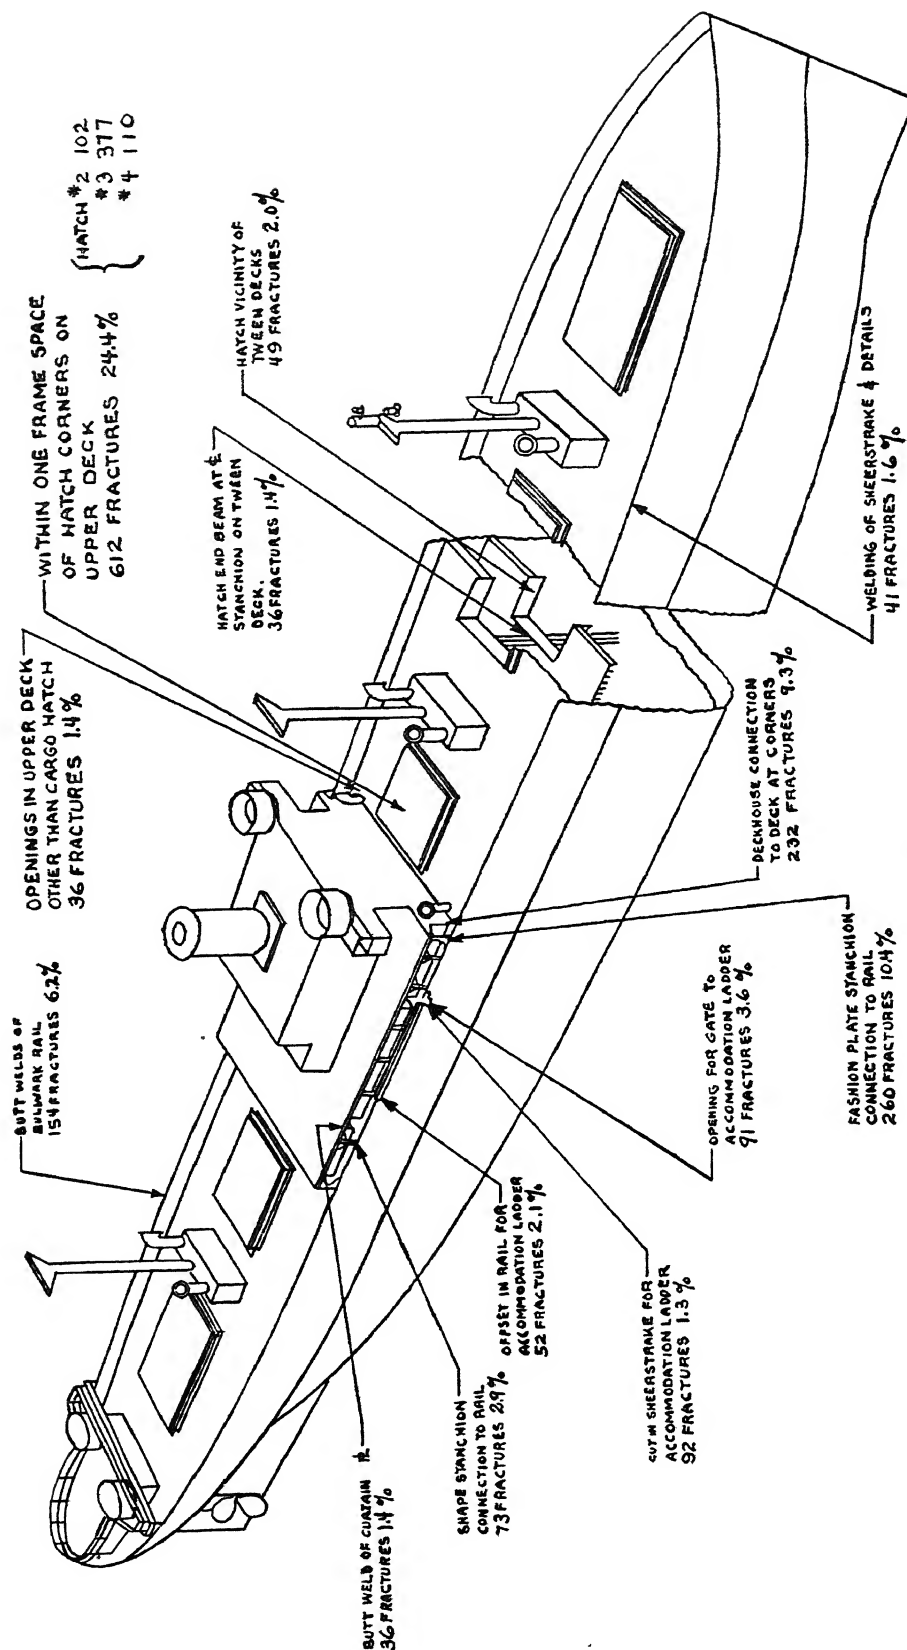
Figure 81.

DETAILS WITH ABNORMAL FREQUENCY OF FRACTURES  
 THESE DATA INCLUDE 2504 FRACTURES OF KNOWN  
 ORIGIN, OCCURRING BEFORE 1 AUG. 45. 158 OTHER  
 FRACTURES OF INDEFINITE ORIGIN WERE REPORTED

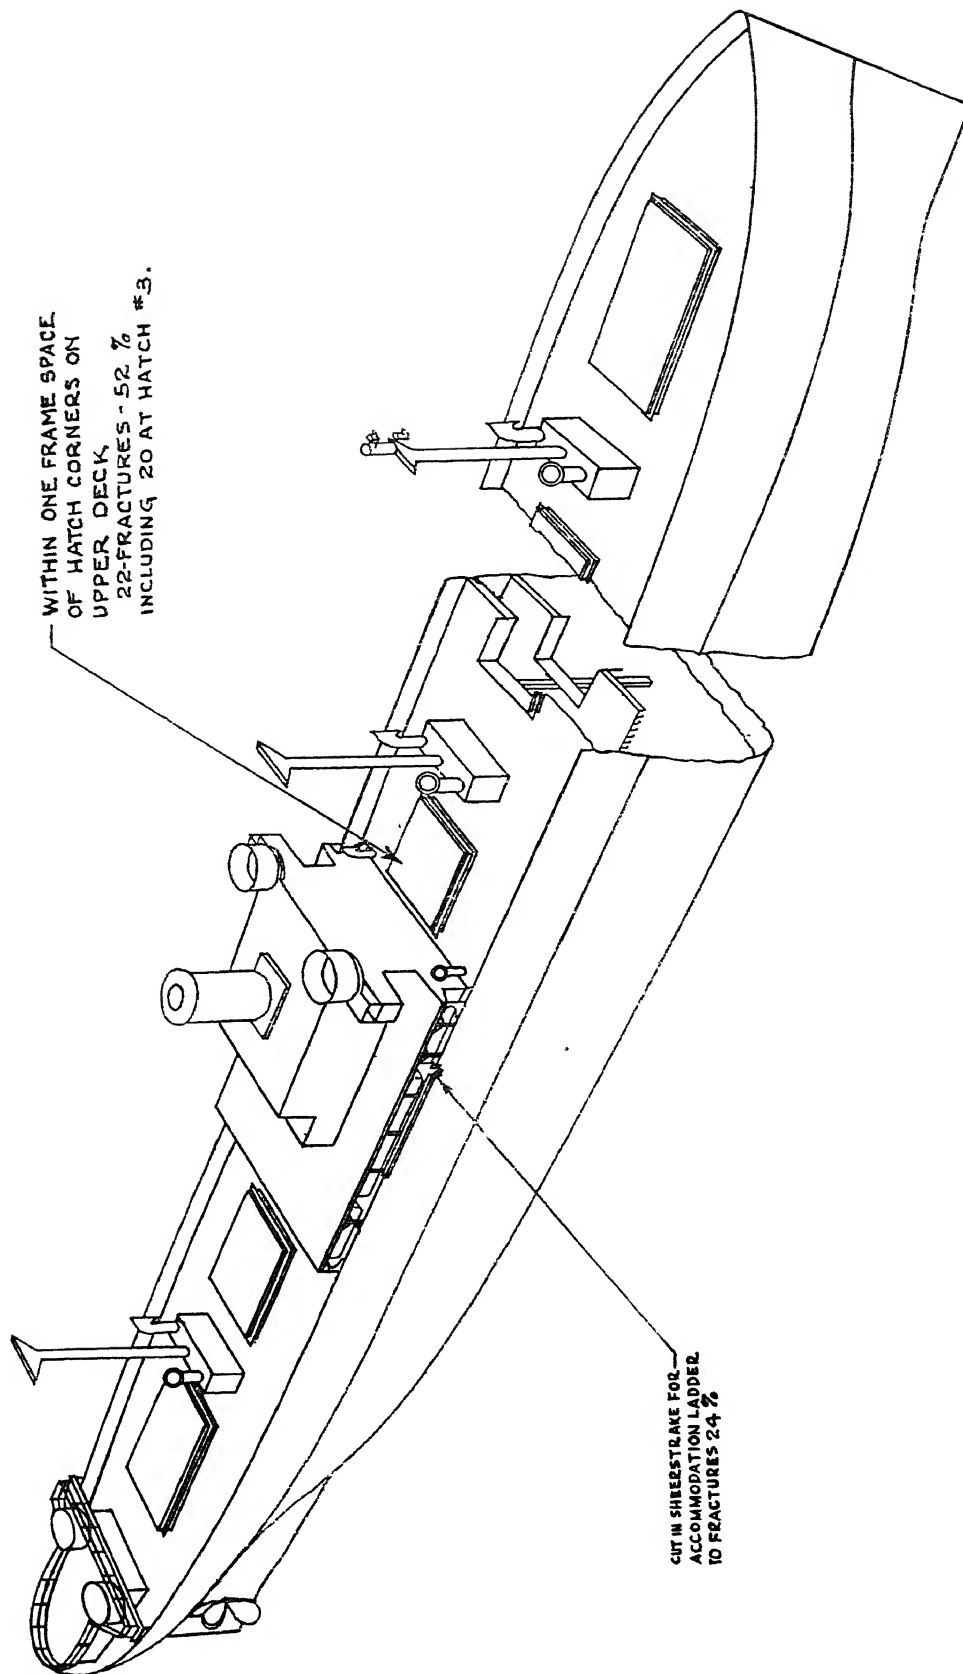
Figure 32.

what different, figure 32. In many cases, the damage was so extensive that the starting point was not located. For this reason, it is only possible to identify positively the starting point of 31 casualties involving 42 fractures. Ten of these fractures or 24 percent started in the sheer strake cut for the gangway ladder. 22 or 52 percent started in the hatch corner including 48 percent at No. 3 hatch.

DETAILS WITH ABNORMAL FREQUENCY OF FRACTURES  
THESE DATA INCLUDE: 4-2 FRACTURES OF KNOWN  
ORIGIN, OCCURRING BEFORE 1 AUG. 45, AND WHICH  
RESULTED IN CLASS 1 CASUALTIES

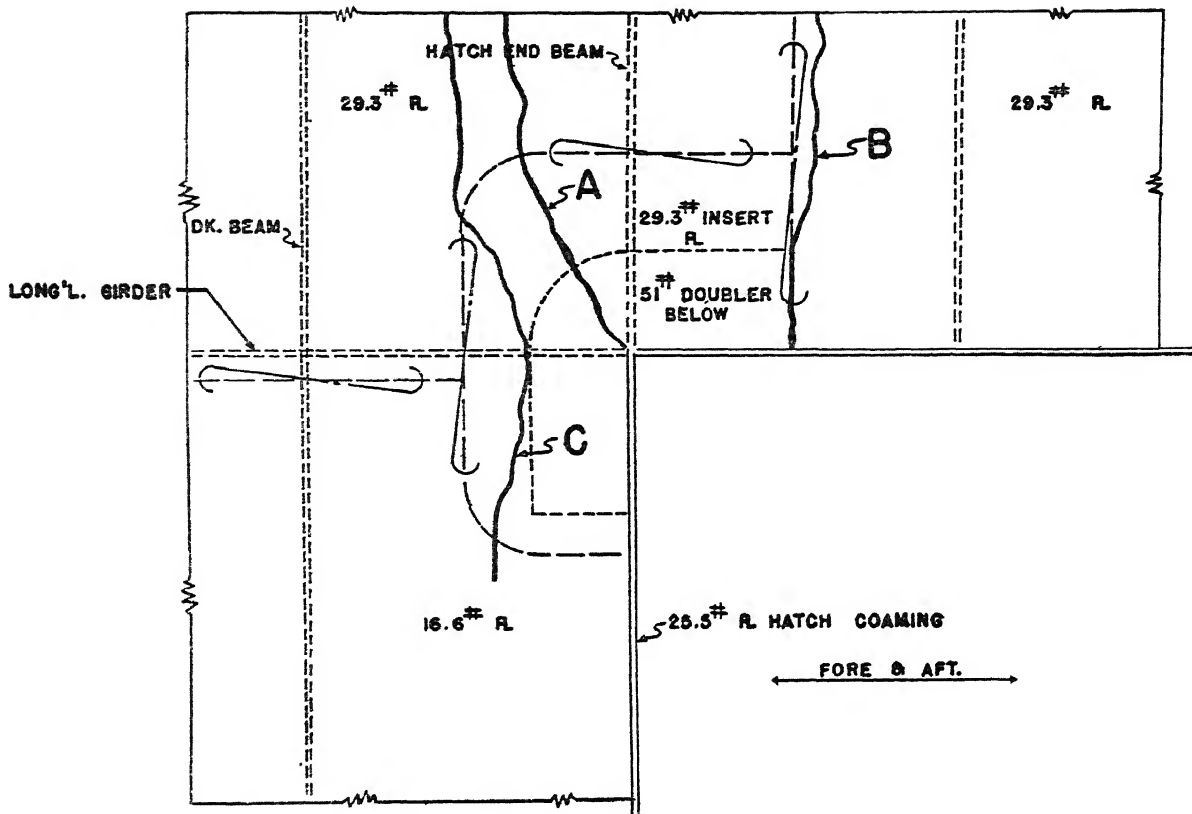
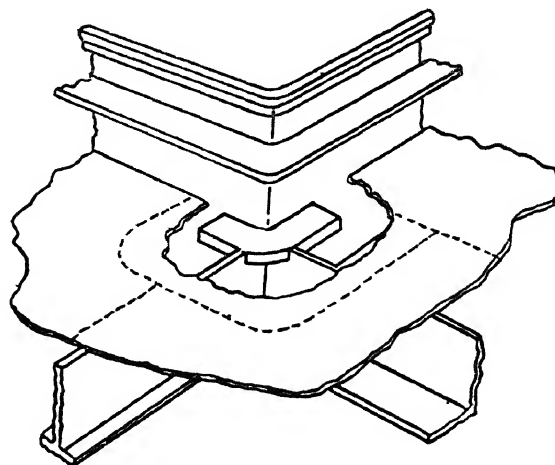
Figure 33.

Figure 33 shows the original design of the hatch corner and indicates the three most important sources of fractures. The greatest number of hatch corner fractures occurred in the manner indicated as A, second greatest as B, and there were several of type C. In the case of the type B fractures, there was involved a combination of design and workmanship. The abrupt end of the 51-pound doubler beneath the

SQUARE HATCH CORNER REINFORCED WITH DOUBLER

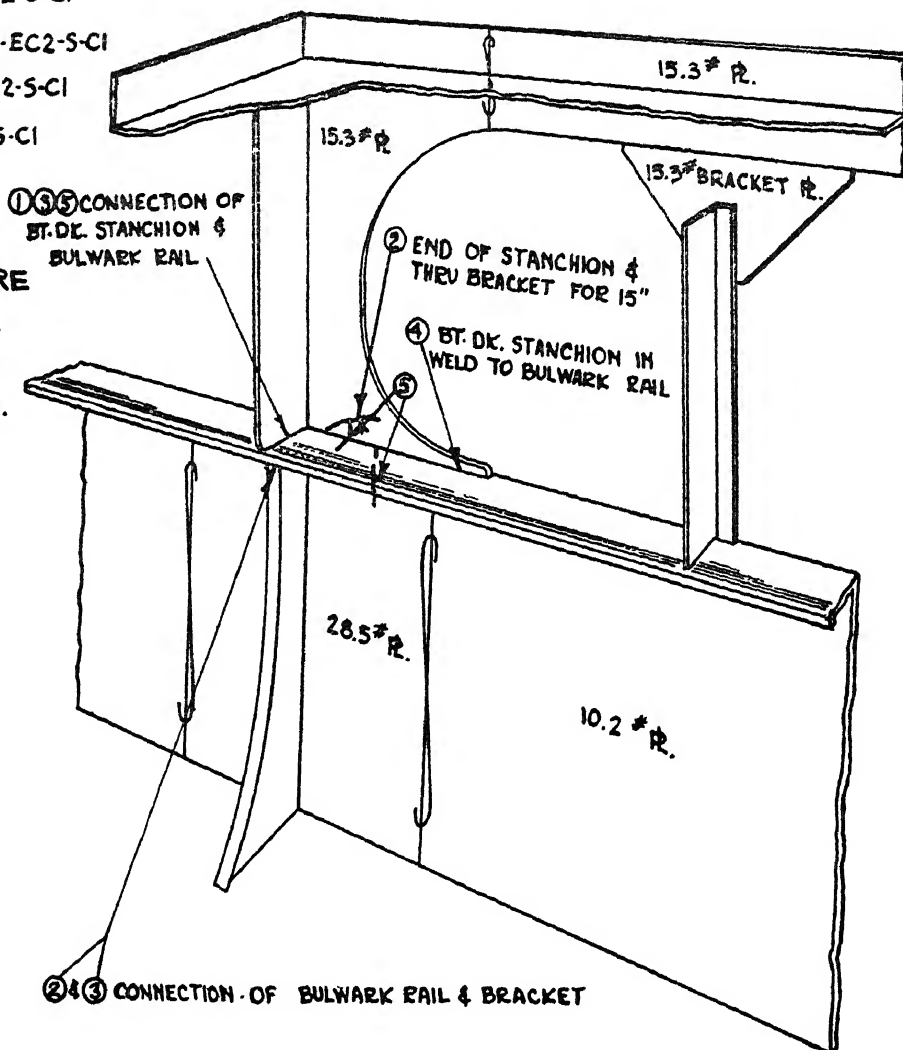
Figure 34.

Many fractures occur at the sheer strake cut for the gangway ladder and the square ending of the boat deck plate stanchions, figures 34 and 35.

- ① LINDLEY M. GARRISON-EC2-S-CI  
FOUND 10 FEB. 1944
- ② WILLIAM G. FARGO-EC2-S-CI  
REPORTED 20 APR. 1944
- ③ WILLIAM H. MCGUFFEY-EC2-S-CI  
1-2 FEB. 1944
- ④ WILLIAM MOULTRIE-EC2-S-CI  
14-27 JAN. 1944
- ⑤ FREMONT OLDER-EC2-S-CI  
FOUND 24 MAY 1944

UP TO 1, AUG, 1945  
260 FRACTURES WERE  
REPORTED TO HAVE  
OCCURRED AT THE  
BOAT DK. STANCHION.

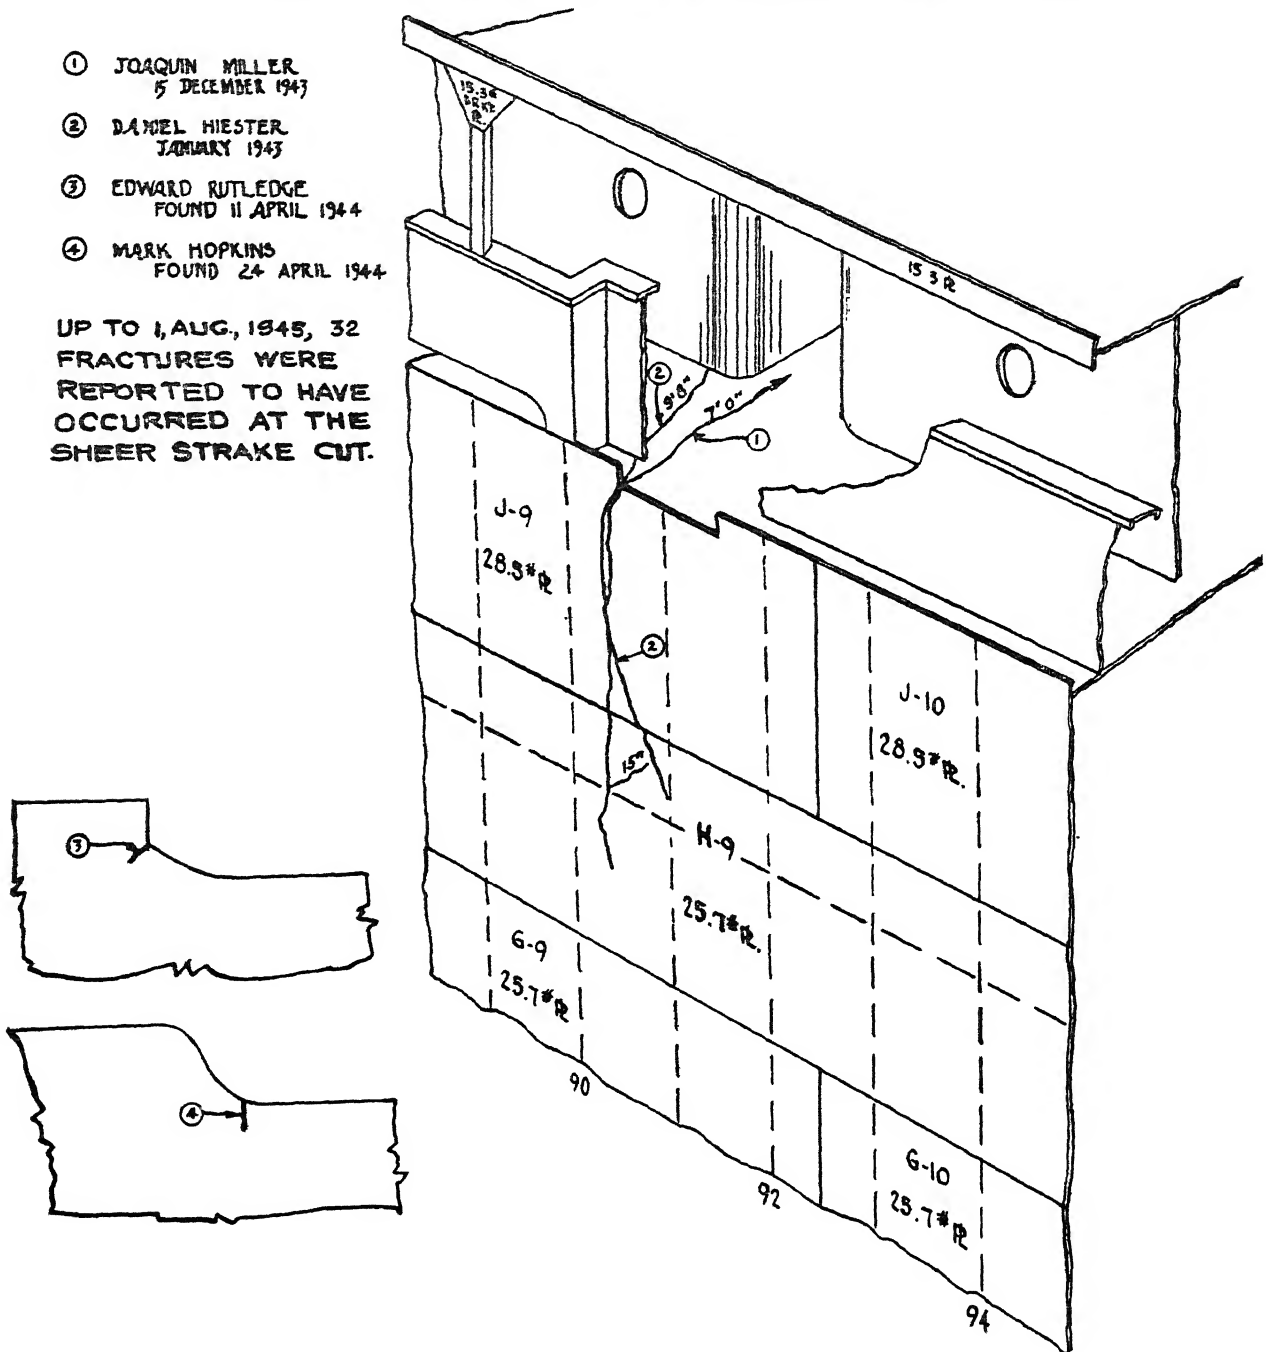
Figure 35.

- ① JOAQUIN MILLER  
5 DECEMBER 1943
- ② DANIEL HIESTER  
JANUARY 1943
- ③ EDWARD RUTLEDGE  
FOUND 11 APRIL 1944
- ④ MARK HOPKINS  
FOUND 24 APRIL 1944

UP TO 1, AUG., 1945, 32  
FRACTURES WERE  
REPORTED TO HAVE  
OCCURRED AT THE  
SHEER STRAKE CUT.

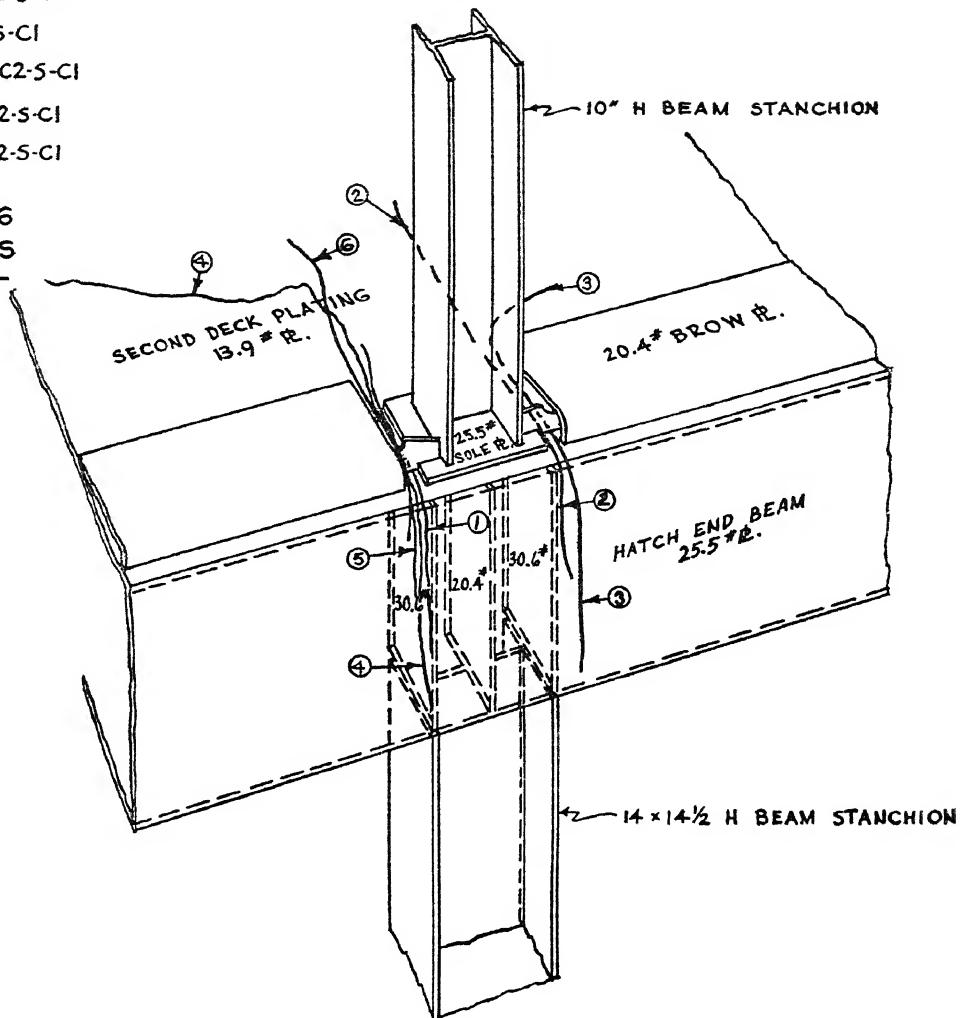
Figure 36.

No. 1 hold. This is just about where maximum pounding would be expected. The thrust of the bottom force overcoming the inertia of the tween deck cargo produces high stresses in the deck over the **H** column. In addition, notches around the sole plate of the tween deck stanchion and the ends of brow plates magnify the stress, figure 36.

- ① JUAN DE FUCA - EC2-S-CI  
FOUND 11 AUG. 1944
- ② LUCIUS FAIRCHILD - EC2-S-CI  
FOUND 17 APR. 1944
- ③ ENOS A. MILLS - EC2-S-CI  
REPORTED 5 FEB. 1944
- ④ JOSEPH REYNOLDS - EC2-S-CI  
25 MAR. 22 APR. 1944
- ⑤ MIDWEST FARMER - EC2-S-CI  
FOUND 29 MAY 1944
- ⑥ MELVILLE JACOBY - EC2-S-CI  
20 MAR. 1944

UP TO 1, AUG, 1945, 36  
FRACTURES OF THIS  
TYPE HAD BEEN RE-  
PORTED, INCLUDING  
19 IN No. 2 HATCH

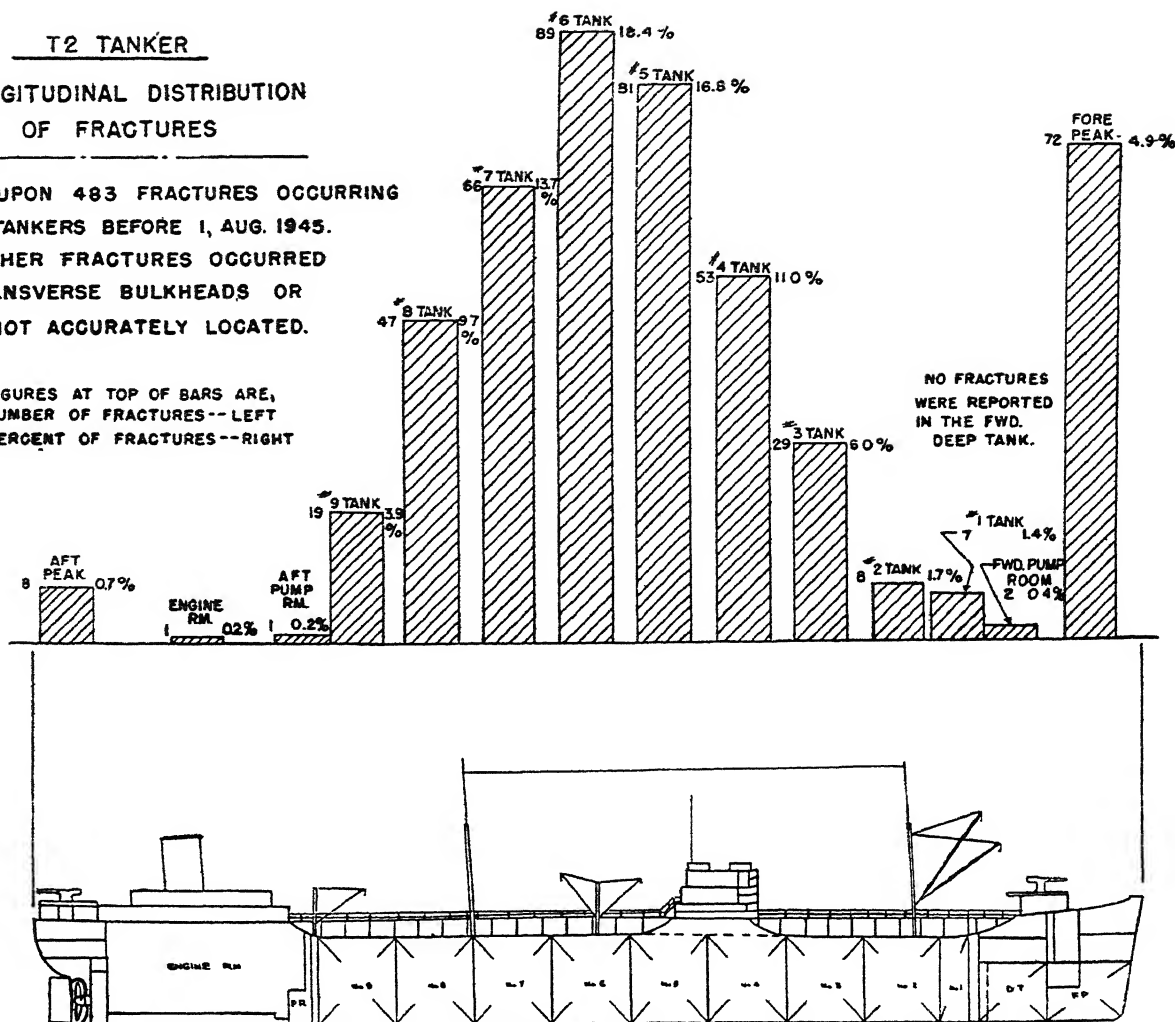
Figure 37.

BASED UPON 483 FRACTURES OCCURRING  
ON T2 TANKERS BEFORE 1, AUG. 1945.  
456 OTHER FRACTURES OCCURRED  
ON TRANSVERSE BULKHEADS OR  
WERE NOT ACCURATELY LOCATED.

The longitudinal distribution of the fractures on the T2 Tankers also shows a peak amidships indicating that bending of the hull is partly responsible for their occurrence, figure 37. All of the nine serious casualties occurred in Nos. 3, 4, 5, 6, and 7 tanks.

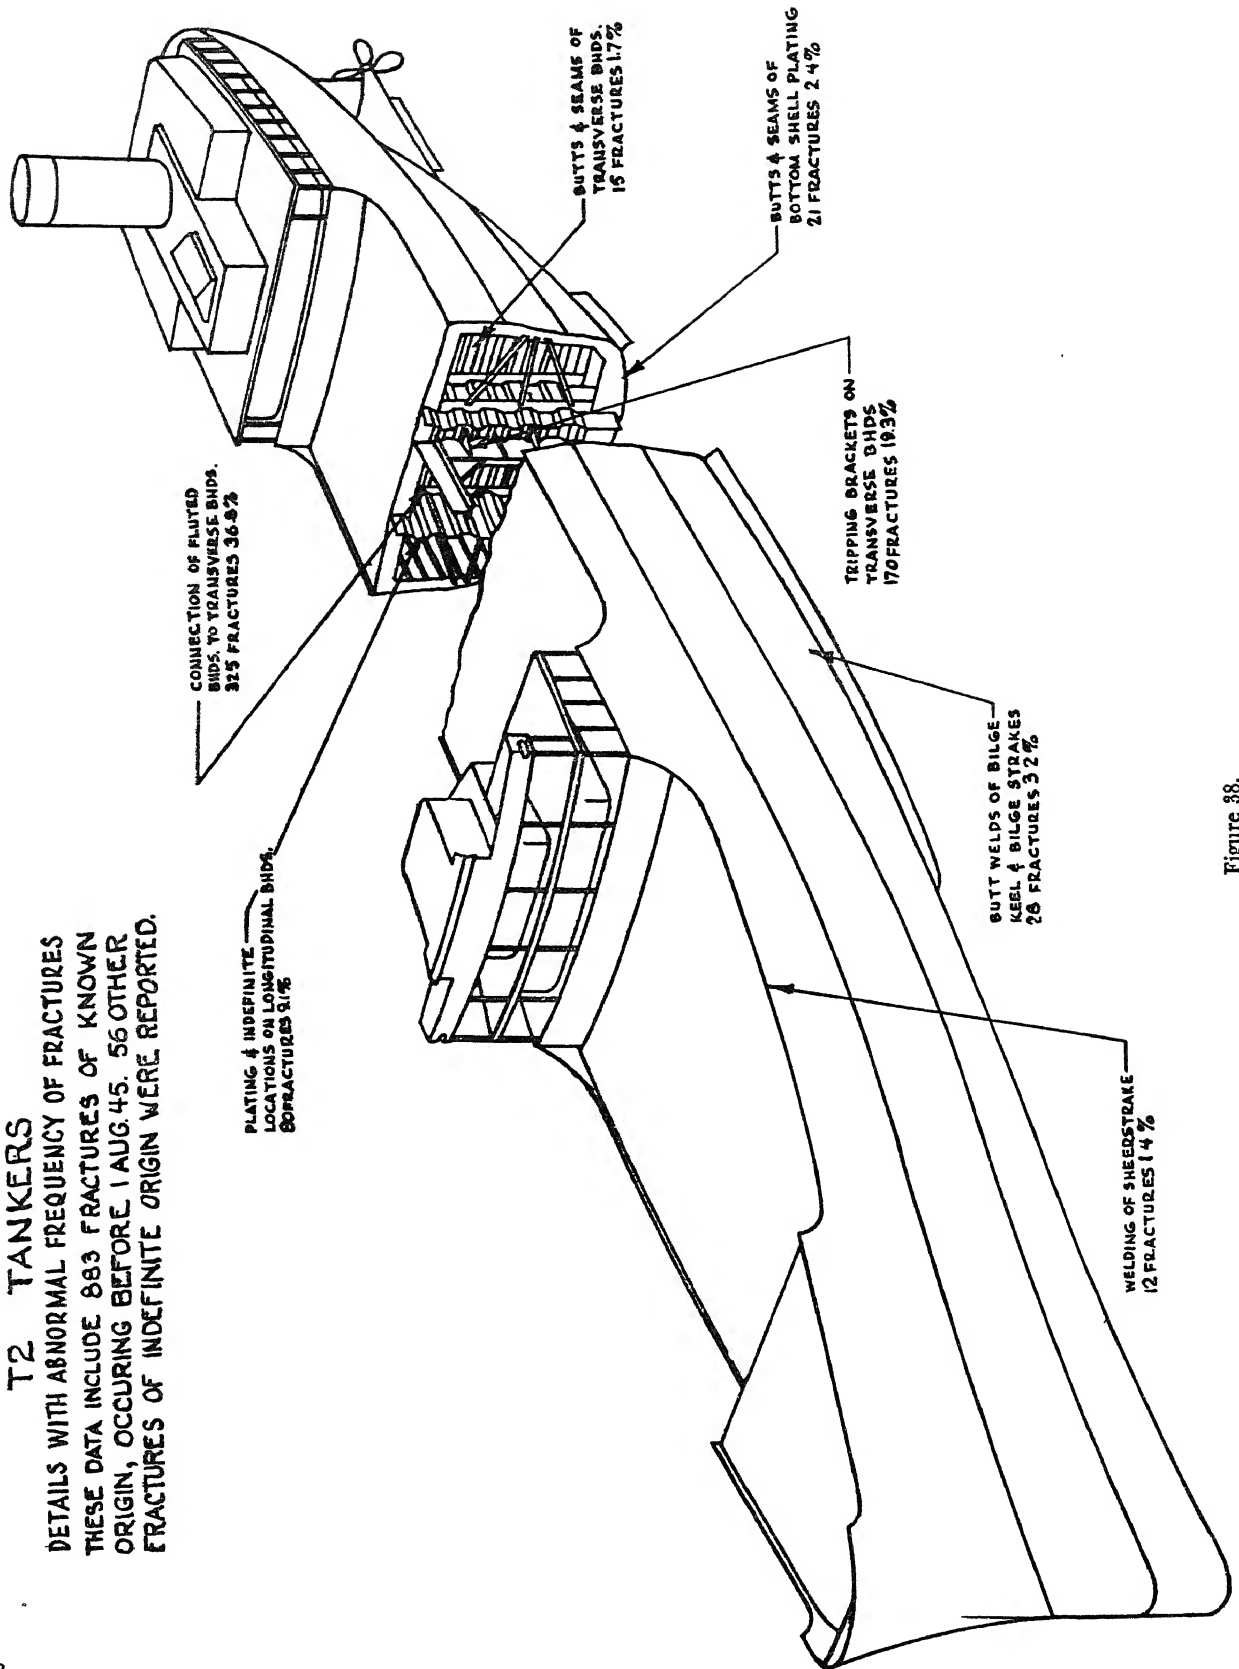
Figure 38.

DETAILS WITH ABNORMAL FREQUENCY OF FRACTURES  
THESE DATA INCLUDE 883 FRACTURES OF KNOWN  
ORIGIN, OCCURRING BEFORE 1 AUG. 45. 56 OTHER  
FRACTURES OF INDEFINITE ORIGIN WERE REPORTED.

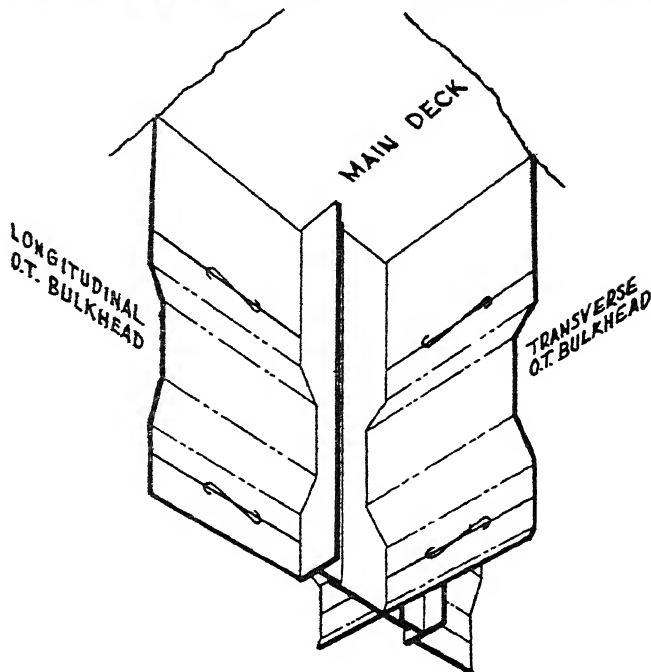
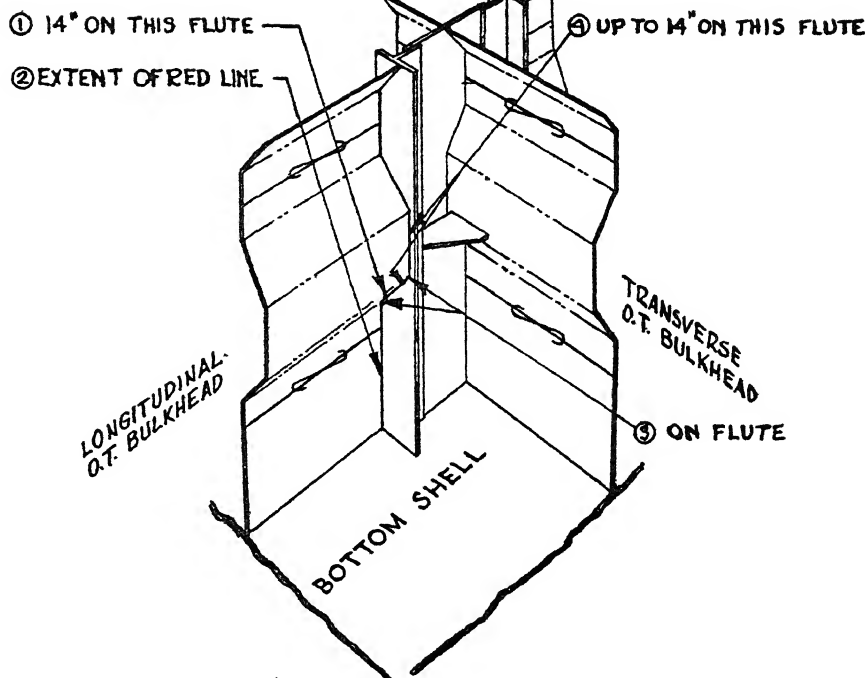
Figure 39.

bulkheads, figure 39. Three hundred twenty-five fractures reported before 1 August 1945, at these intersections have been traced to design details which cause a stress concentration under the influence of both hull bending and local hydrostatic loads. It would appear from the longitudinal distribution of these fractures that the hull bending stresses have considerably more to do with the failures than local hydrostatic loading, either static or dynamic.

**T2-SE-A1 TYPE**  
**COMPOSITE SKETCH OF FRACTURES**  
**CONNECTION OF FLUTED LONGITUDINAL BULKHEADS TO TRANSVERSE BULKHEADS**

- ① NEW LONDON  
REPORTED 26 JUNE, 1944
- ② NORTHFIELD  
FOUND 12 SEPT., 1943
- ③ CHURUBUSCO  
REPORTED 12 JUNE, 1944
- ④ RIVER RAISIN  
REPORTED 7 JULY, 1944

UP TO 1 AUG. 1945 325 FRACTURES  
 WERE REPORTED AT THESE  
 BULKHEAD INTERSECTIONS.

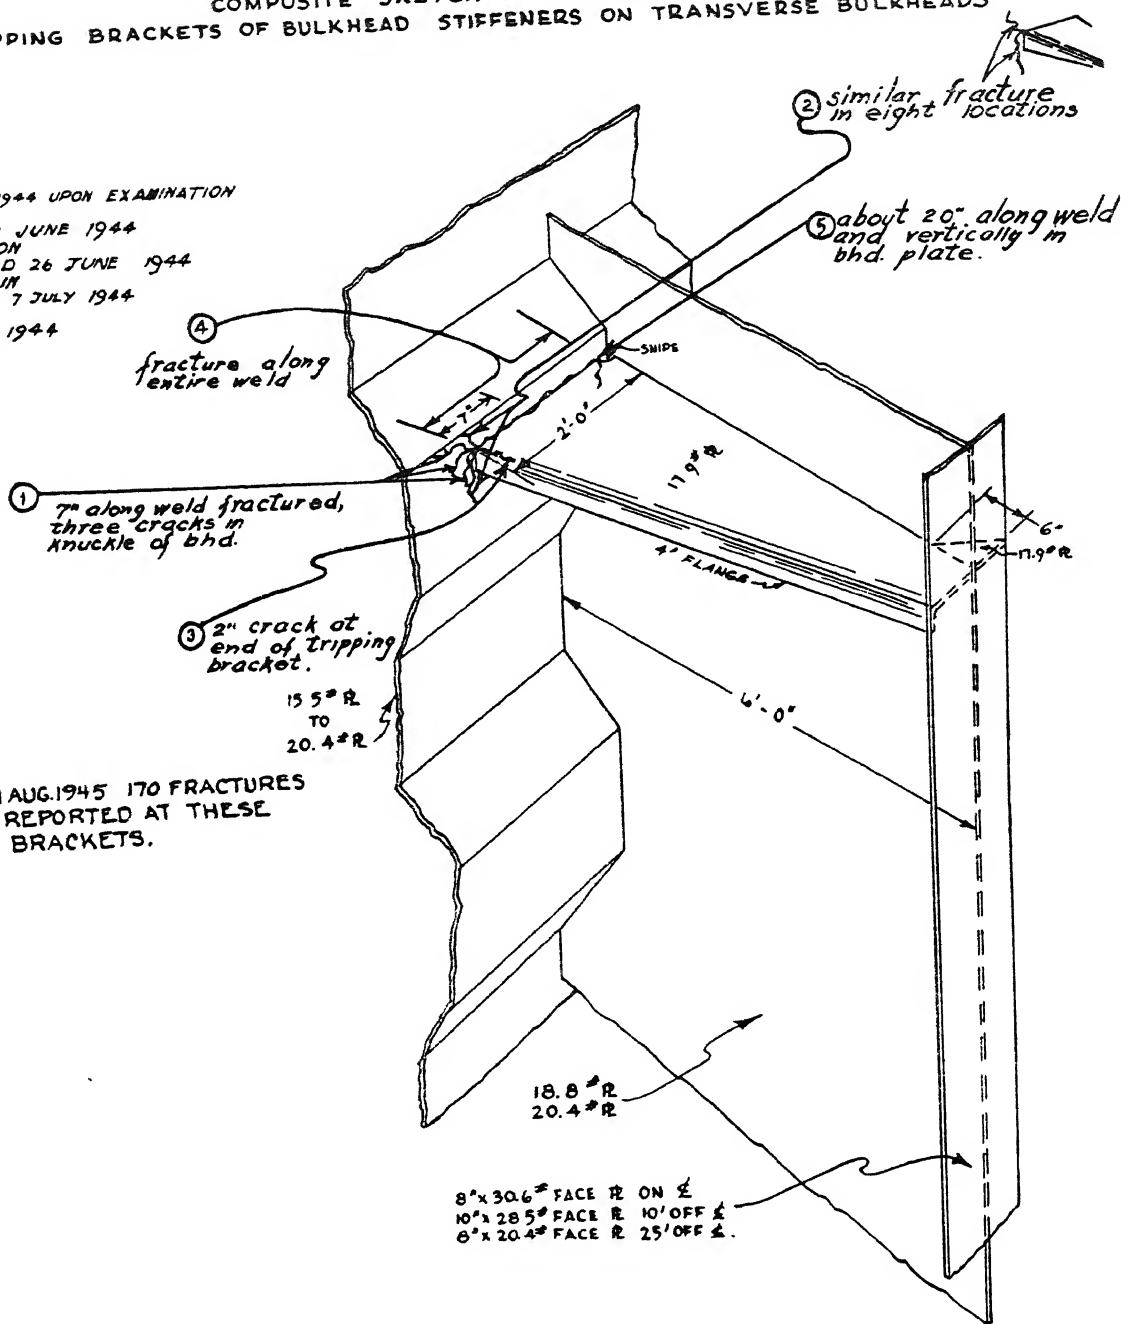
- ① NORTHFIELD  
19 APRIL, 1944 UPON EXAMINATION
- ② RANIER  
FOUND 21 JUNE 1944
- ③ NEW LONDON  
REPORTED 26 JUNE 1944
- ④ RIVER RAISIN  
REPORTED 7 JULY 1944
- ⑤ NEHALEM  
AUGUST 1944

UP TO 1 AUG. 1945 170 FRACTURES  
 WERE REPORTED AT THESE  
 BRACKETS.

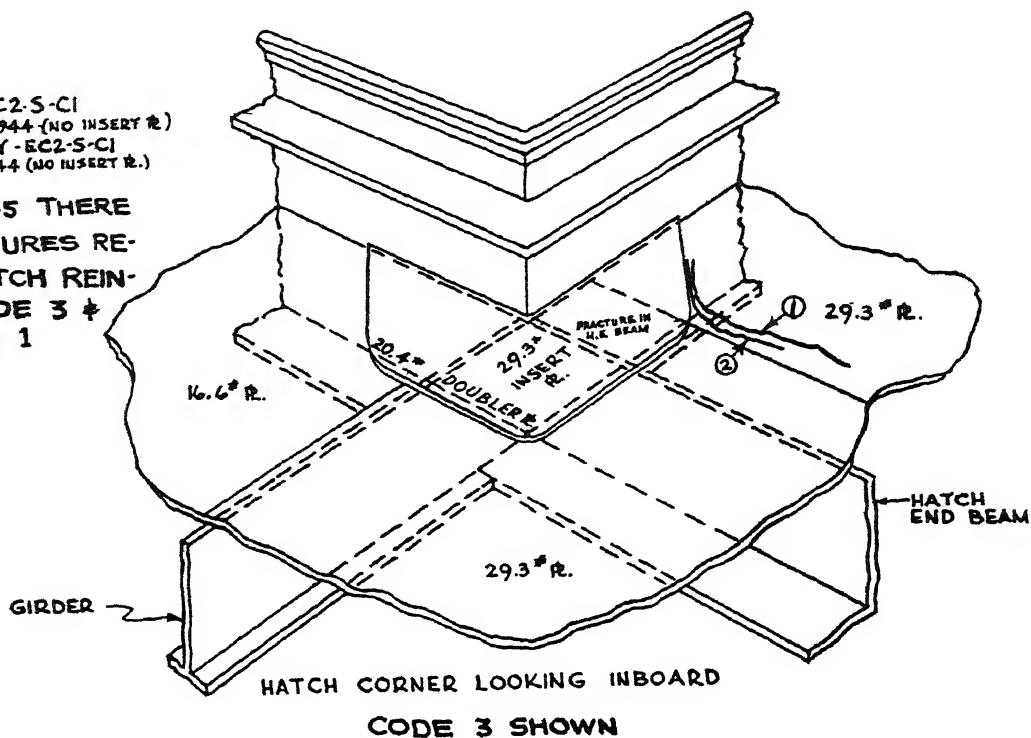
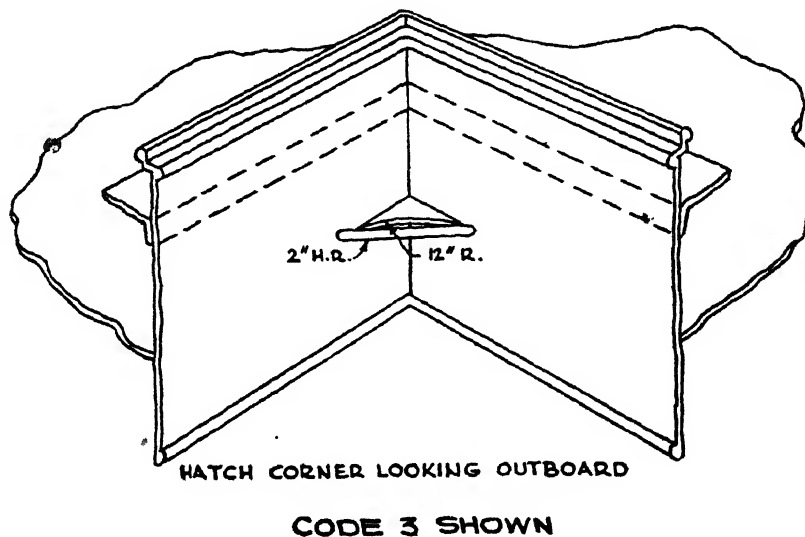
Figure 47.

- ① JOHN STRAUB-EC2-S-C1  
FOUND 22 MAR. 1944 (NO INSERT PL.)
- ② WILLIAM A. HENRY-EC2-S-C1  
FOUND 25 SEPT. 1944 (NO INSERT PL.)

UP TO 1, AUG. 1945 THERE  
WERE 5 FRACTURES RE-  
PORTED ON HATCH REIN-  
FORCEMENT, CODE 3 &  
NONE ON CODE 1

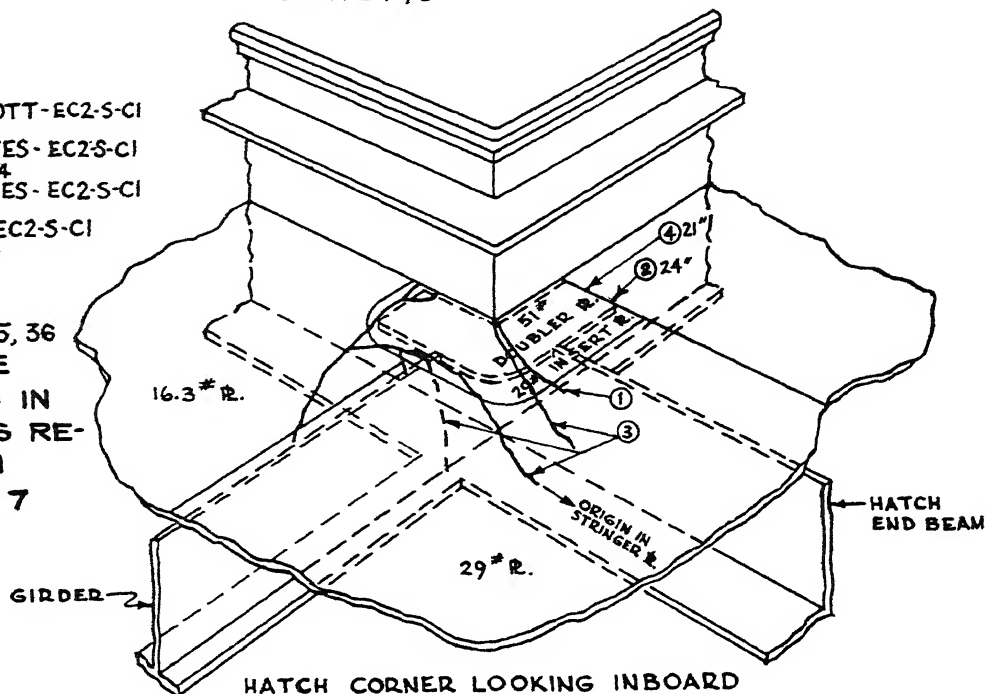
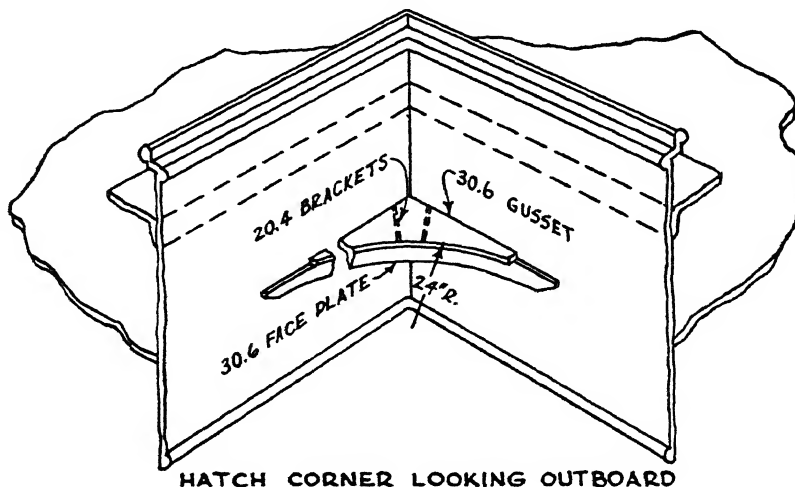
Figure 48.

- ① JOSHUA B. LIPPINCOTT-EC2-S-CI  
29-30 JAN. 1944
- ② WILLIAM BLACK YATES-EC2-S-CI  
30 MAR.-10 APR. 1944
- ③ FERDINANDO GORGES-EC2-S-CI  
16 DEC. 1944
- ④ LYMAN BEECHER-EC2-S-CI  
FOUND 3 MAR. 1944

UP TO 1, AUG, 1945, 36  
 FRACTURES HAVE  
 BEEN REPORTED IN  
 HATCH CORNERS RE-  
 INFORCED WITH  
 CODES 5, 6, & 7

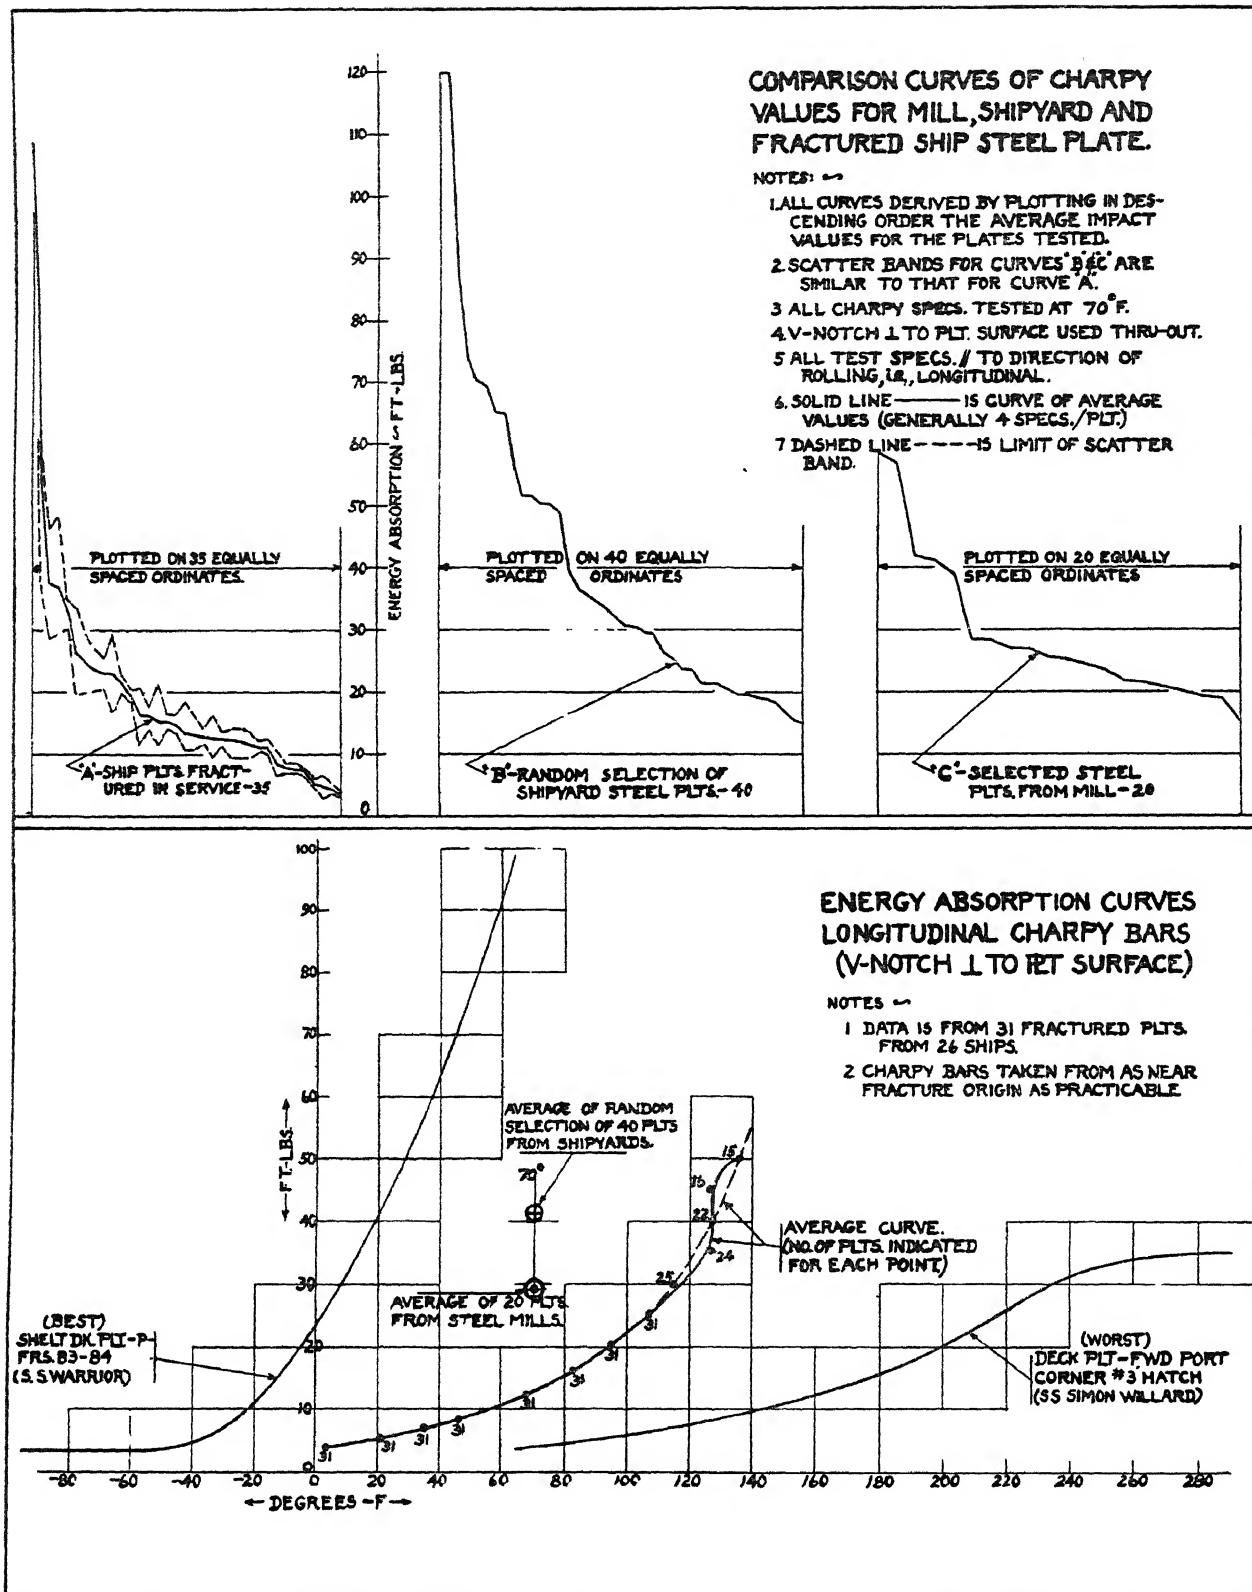
Figure 57.

Data for the 31 plates have been averaged with respect to temperature: the averages are shown in the lower portion of figure 57, along with the best and the worst curves. The energy absorption values at 70° F are also indicated for each of the plates tested (upper left) with dotted lines to indicate the spread of the energy absorption values covered by the four specimens tested at that temperature.

Data from Groups B and C have been entered in the temperature diagram on figure 57 and comparison suggests that specimens of steel in Group A (from fractured plates) were more notch sensitive than

Figure 57 shows that the steel in fractured plates loses the ability to absorb energy in the notched condition as temperature goes down. Low temperature is said to increase the notch sensitivity of the steel. Experience also shows that fractures in service gain in frequency at lower temperatures. It would be
